## Development of Sawdust in Cement Particle Board Using Eco-Friendly Process

Cement,  
Eco-Friendly Process,  
Particle,  
CO<sub>2</sub>.

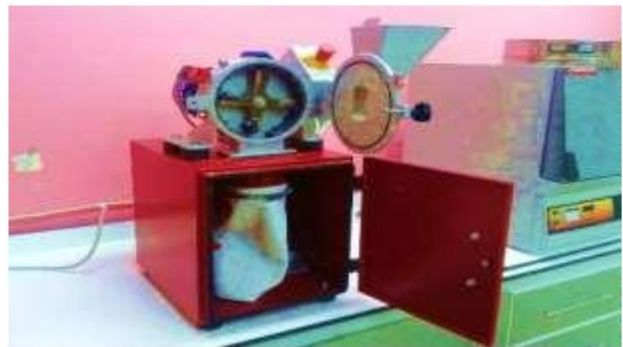
Figure 1. The humming machine for producing sawdust.

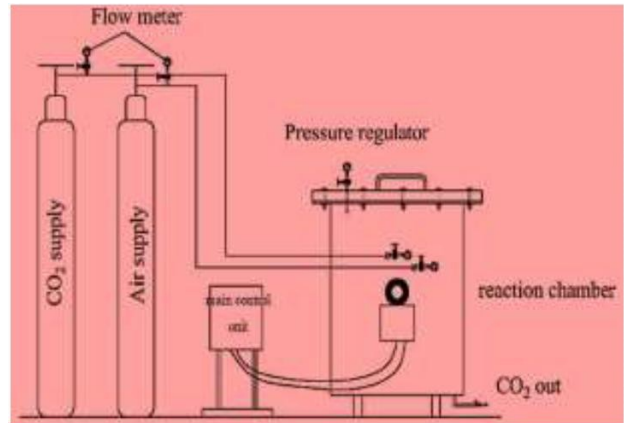
**Figure 2.** Experimental setup for CO<sub>2</sub>-curing.

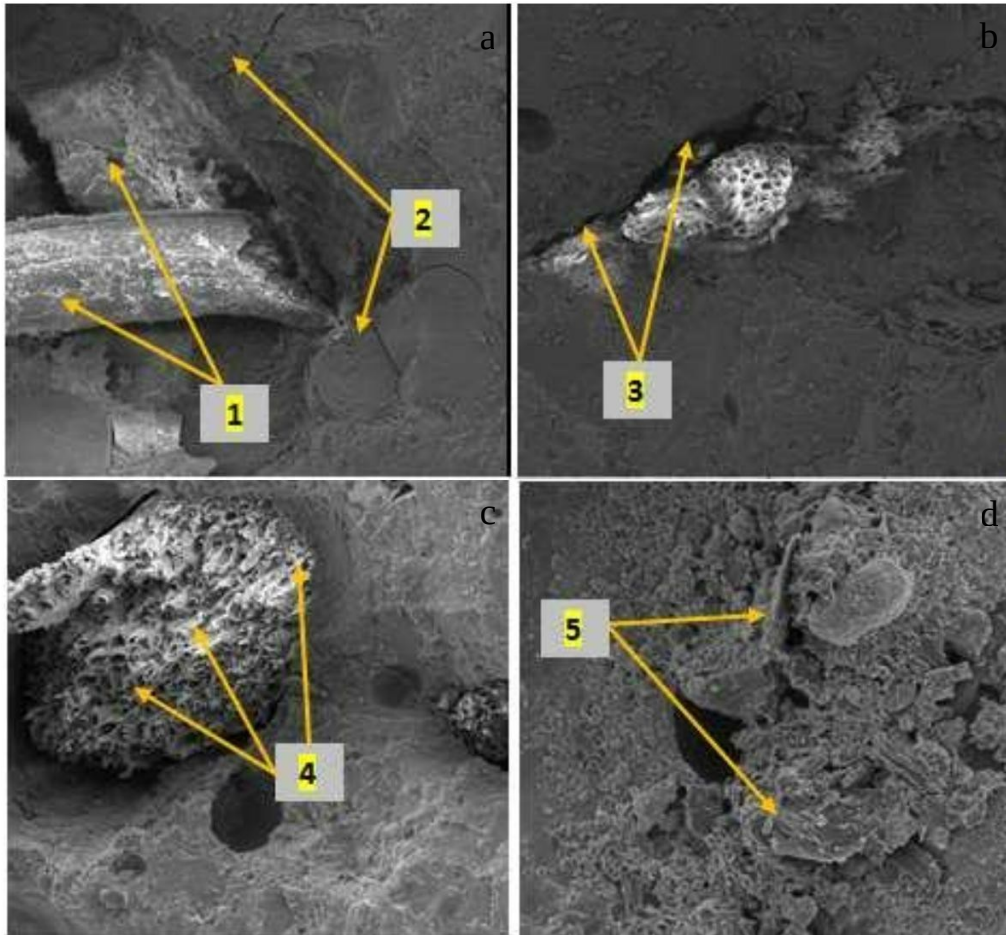
Figure 3. SEM micrographs of the broken surfaces of the following: (a) treated, (b) untreated, (c) CO<sub>2</sub> cured, and (d) added nano slag.

Figure 3 shows sawdust particleboard with fractured surfaces captured in SEM micrographs before and after various acceleration effects. Five representative pictures were taken for each sample, and only one SEM micrograph was selected from the set. Ca(OH)<sub>2</sub> appears to be clearly coated on the surface of the sawdust particles (arrow 1/a). Moreover, it is clear that after sawdust pretreatment, there is a strong bond between the sawdust particles and the cement paste, which is why the cracks form far away from the ITZ (arrow 2/a). Therefore, the fracture cracks start when failure occurs within the ITZ and on the sawdust particles. At the same time, the cross-section of the sawdust particles used here consists of empty black holes (arrow 3/b). In the non-carbonized samples, these black holes are not filled; however, for the carbonized boards, they are completely filled with CaCO<sub>3</sub>. After CO<sub>2</sub> curing, plate-like CaCO<sub>3</sub> can be seen on the particle surface and around the fiber pores (arrow 4/c). To this end, the carbonized cementitious matrix is denser than the control mixture, which can improve the interfacial transition zone between the particles and the cementitious matrix, undoubtedly increasing the flexural strength of the final composite. Also, from these micrographs, it can be seen that the addition of nano-slag to the cementitious matrix resulted in a

denser and more compact cementitious matrix, as shown by (arrow 5/d). This improved contact between the sawdust and cementitious matrix can improve the adhesion between the two, reduce the ITZ thickness, and increase the panel density. This is due to the filling effect of carbonate crystals

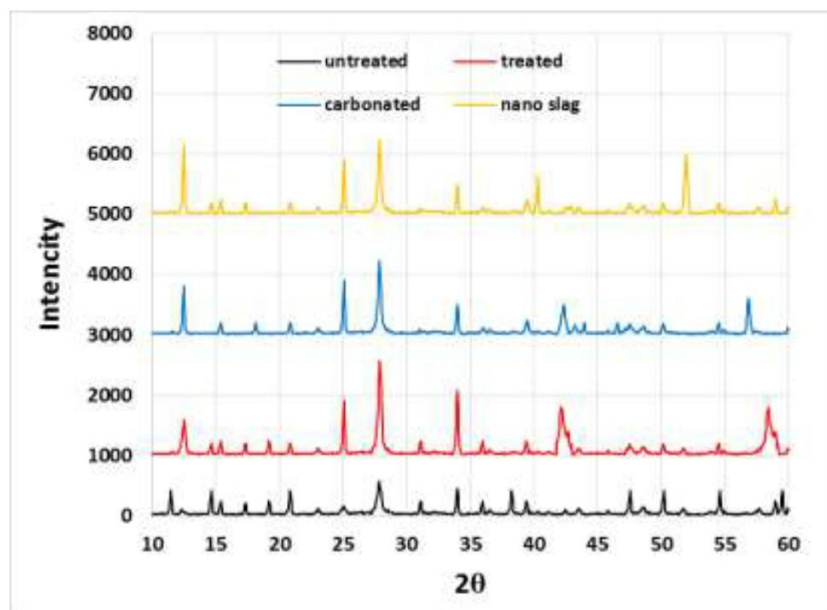
Figure 4. X-ray diffraction results for the following conditions: (a) untreated; (b) treated; (c) carbonated; and (d) with nano slag.

produced by carbonation and nano-slag. Figure 4 shows the results of X-ray diffraction spectra. Four representative mixtures - untreated test matrix, treated, carbonized, and including nano-slag - are represented by the data. For each of the

studied mixtures, large humps ( $\text{CaCO}_3$  and CSH) were observed in the diffraction pattern between  $13^\circ$ ,  $25^\circ$ , and  $30^\circ$   $2\theta$  values. At the same time, small peaks in the diffraction pattern were observed between  $34^\circ$ ,  $43^\circ$ , and  $52^\circ$   $2\theta$  values ( $\text{Ca}(\text{OH})_2$  and quartz Qz). This could be due to the presence of amorphous glassy material due to increased cementitious activity (in the case of treated sawdust), carbonate hardening or the presence of carbonate crystals due to pozzolanic activity (related to the addition of nano-slag). It was found that the crystallinity of the untreated sawdust particleboard samples was lower than that of the treated carbonate and nano-slag samples. These humps indicate the formation of aluminosilicate hydrate gel C-A-S-H, which was identified as the main reaction product of the hydration process in the specific diffraction pattern.

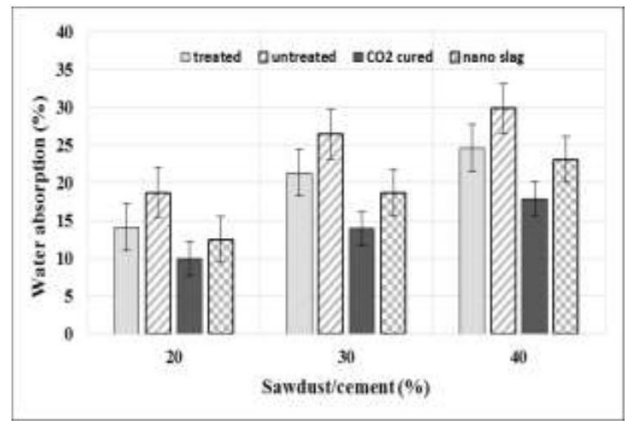
Figure 5. Cement-bonded particleboard's water absorption.

The data analysis with the above testing methods is instructive in order to know quantitatively the influence of different parameters on the mechanical, microstructure and physical properties of CPB. The treated and untreated sawdust particleboard differs significantly in the results. Composite board of the treated sawdust has greater flexural strength and density than untreated board. Moreover, all the treated sawdust particleboards exhibit lower moisture absorption and thickness swelling compared to that of treated wood. Carbon dioxide cured particleboard All of the  $\text{CO}_2$  cured particleboards had higher MOR and density, but lower MA and thickness swelling rates than those for uncured particleboard. That is to say, the amount of rebound decreases after immersion in water for carbon dioxide-cured products and those hardened after 28 days resulting from flowing are higher than those prepared by conventional method. Figures 5 and 6 depict the relationship in sawdust-cement's ratio vs. thickness expansion rate, and moisture absorption rate under different treatment conditions. Thickness swelling rate, moisture absorption rate and ratio of sawdust to cement of all the panels were significantly increased by 210% and 66%, respectively after 24 h immersion. This is due to the relatively high permeability of wood particles in the board. Also, with the addition of wood chip treatment 20%, carbonization 43%, and nano-slag 24% reduction rate in moisture absorption ratio, thickness expansion ratio were observed as a value of 24%.

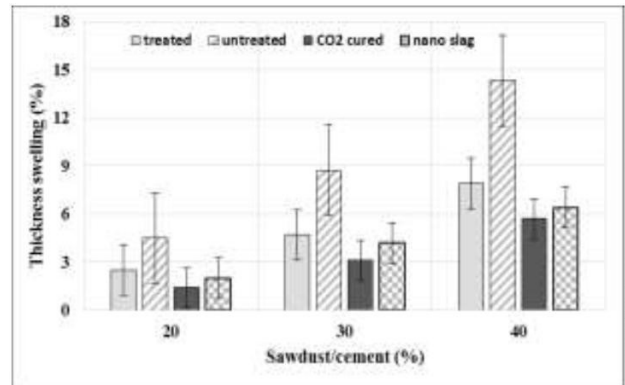
Figure 6. Swelling of cement-bonded particleboard thickness.

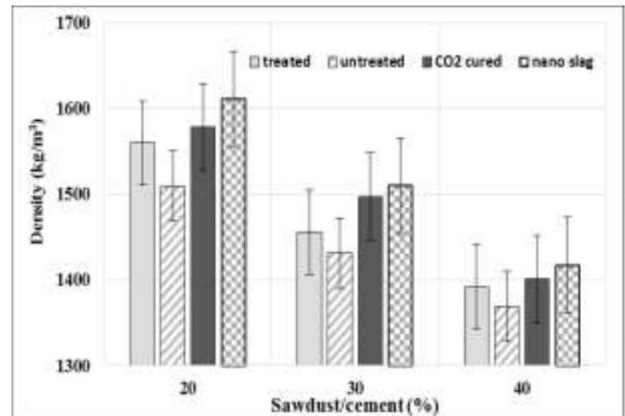
Figure 7. Density of particleboard bound with cement.

respectively, compared to untreated sawdust particleboards. The elimination of extractable materials and the filling effect of nano-slag and its pozzolanic reaction could be the main reasons for these improvements. As can be seen in Figures 7 and 8, the denser particleboards did not result in higher flexural strength. This could be due to the petrification of sawdust particles due to carbonization solidification and improved interfacial transition zone, as shown in the subsequent SEM micrographs, and CO<sub>2</sub> solidification improved the bond between sawdust particles and the matrix. As a result, the bond between sawdust particles and the matrix increased, and the ITZ became thicker and stronger. Panels made from treated particles had higher density and flexural strength values compared to those made from untreated particles. Moreover, the density and flexural strength decreased the most (6%, 11%) and (17%, 48%), respectively, when the sawdust/cement ratio increased from 20% to 30% and 40%. However, after sawdust treatment, carbonization hardening and addition of nano-slag, the increase rates of density and flexural strength were 4%, 5% and 7%, 100%, 134% and 126%, respectively. In conclusion, these results all indicate that sawdust pretreatment, board carbonization and the addition of nano-slag help to improve the compatibility of sawdust particles with cement, thereby improving the strength of the final product.

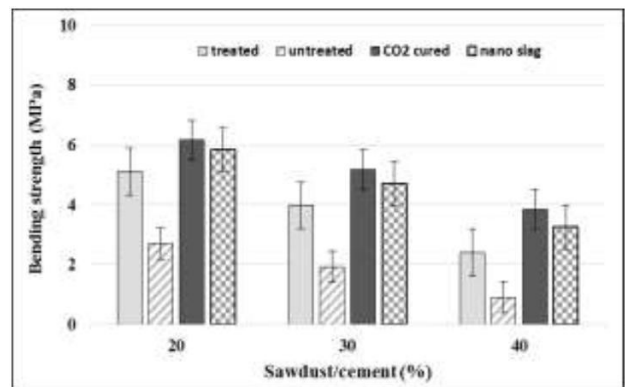
Figure 8. The bending strength of particleboard bound with cement.
